TESTING OF BULLDOG PVC RESTRAINT JOINT FOR TRENCHLESS TECHNOLOGY

Prepared for Bulldog Restraint System™

August, 2009

Center for Underground Infrastructure Research and Education

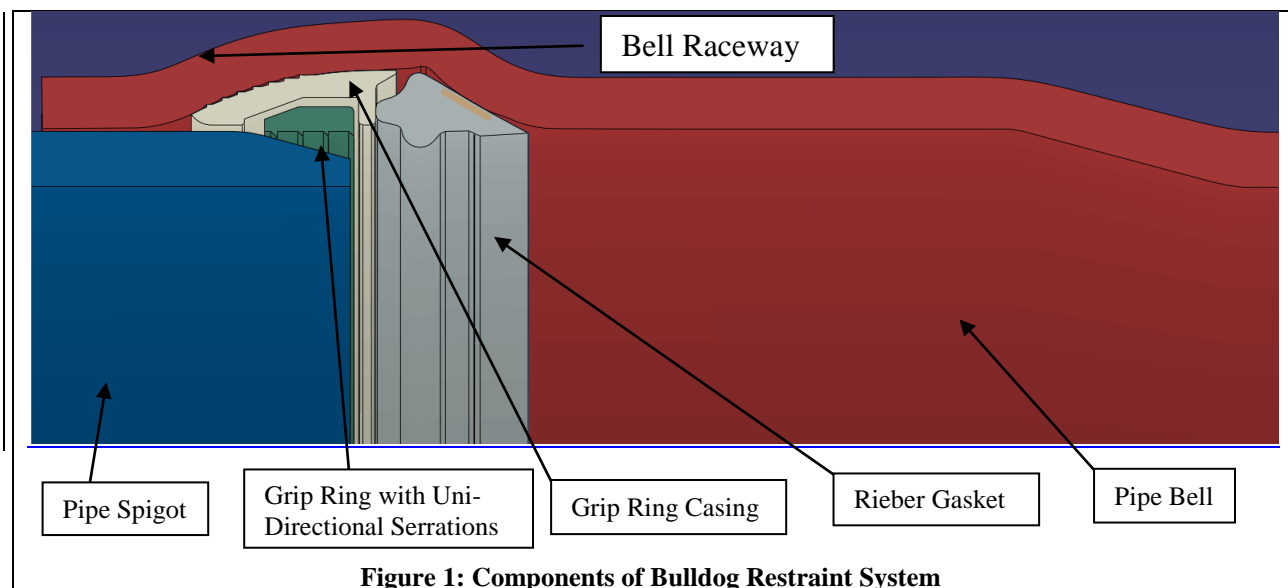
The current version of the Bulldog™ is designed for integration into AWWA C900 PVC pipe and fittings in diameters 4-inch through 12-inch. The mechanism consists of a metal casing that sits adjacent to the Rieber gasket in the bell; and the casing is molded into the raceway of the bell during pipe belling. A C-shaped grip-ring with several rows of uni-directional serrations is

manually inserted into the casing at the manufacturing facility. Both the casing and the grip ring are made of ductile iron that has been coated using an electro-coating process that achieves a uniform thickness and provides superior corrosion resistance. When the pipe arrives at a jobsite, the bell already contains the casing with the grip ring inserted in it, and no additional hardware is needed to provide a restrained joint. Figure 1 shows a cross-sectional view of the components in the joint.

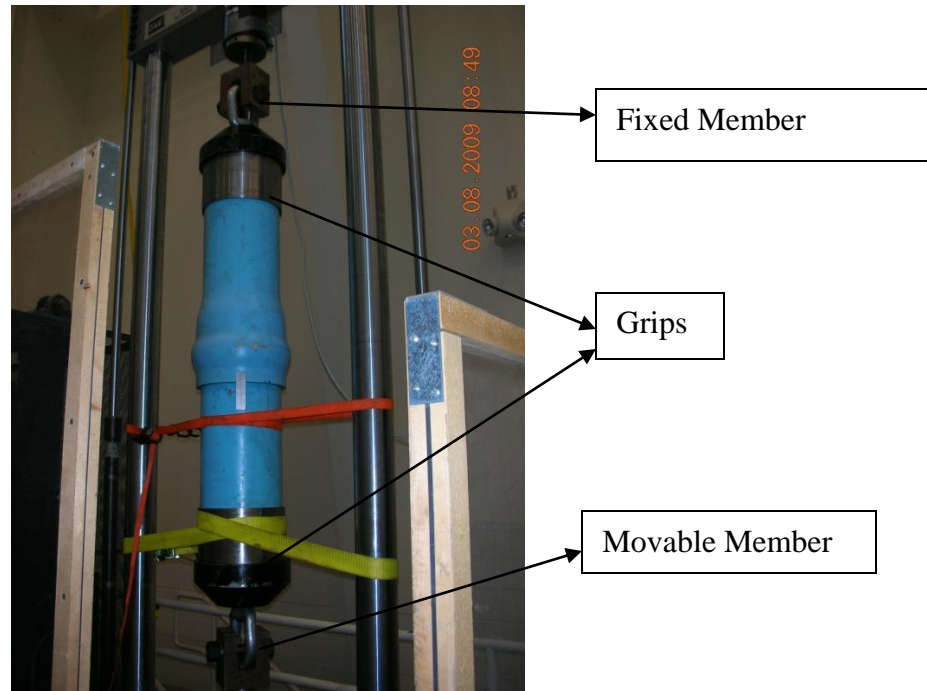
Figure 2: Apparatus Assembly for 8" Pipe

Grips are used for holding the test specimen between the fixed and the movable member of the testing machine. In this test, fixed grips which made uniform serrations to prevent the slippage of the specimen were used to hold the specimen rigidly between the fixed and the movable members. Heads with teeth were inserted into the ends of pipe specimen which acted as grips to hold the pipe during the test. The head used for 8” pipe is shown in Figure 2.

The pipe specimens were cut to sizes required so that the pipe assembly length would be as desired for the test. The lengths of pipe assemblies tested are given in Table 1. Rectangular strain gage rosettes were carefully attached to the pipe with the center strain gage (strain gage at 45° angle from rest of strain gages) along the length of the pipe as can be seen in Figure 3. Bell and spigot pipes were assembled using MTS compression machine. Grip heads were inserted into both ends of the pipe assembly and tightened as instructed by the designer of the grip. End of the head were marked in order to monitor any slippages. The specimens were loaded into the MTS machine as shown in Figure 2.

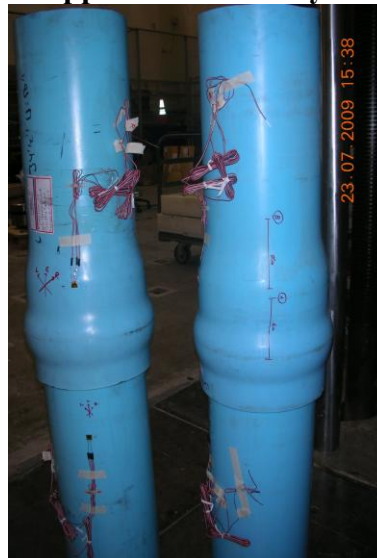
Figure 3: Specimen Pipe Assembly with Rosette Strain Gages

Two rectangular strain gage rosettes were attached on the specimen in order to measure the strain and strain directions on the specimen. One assembly of strain gage rosettes was placed on the bell side of the pipe assembly while the other was on spigot side of the pipe assembly as shown in the Figure 3.

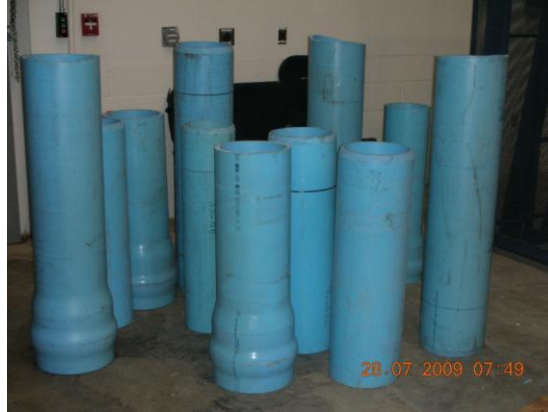
Figure 4: Pipe Specimens as Received

Pipe specimens were received at the CELB unassembled and with equal numbers of bell and spigot ends. Pipe specimens as received are shown in Figure 4. Pipe specimens were provided by two different PVC pipe manufacturing companies.

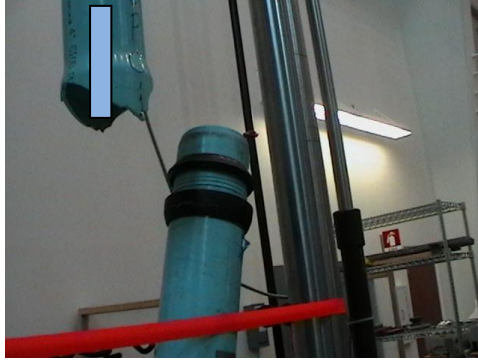
Figure 5: Failure of Specimen One.

Joint of the specimen one failed at the bell of the pipe assembly as shown in Figure 5.

Seventy-five percent of the samples failed at the spigot. Principal strains were in circumferential directions in majority of occasions (seventy-five percent). The reason for spigot failing in majority of occasions may be extra thickness provided to the bell. In case when bell has failed (for 4" and 6" pipes), failure of spigot for same diameter of pipe has been at higher loads. Spigot failures (for 8" pipes) have been observed at similar loads. This indicates that safe load can be predicted on basis of capacity of spigot (within BRJ) to withstand tensile load. However, bell end has to be manufactured to be able to withstand more tensile load within the joint than spigot, because bell-end has more room for increase in thickness.

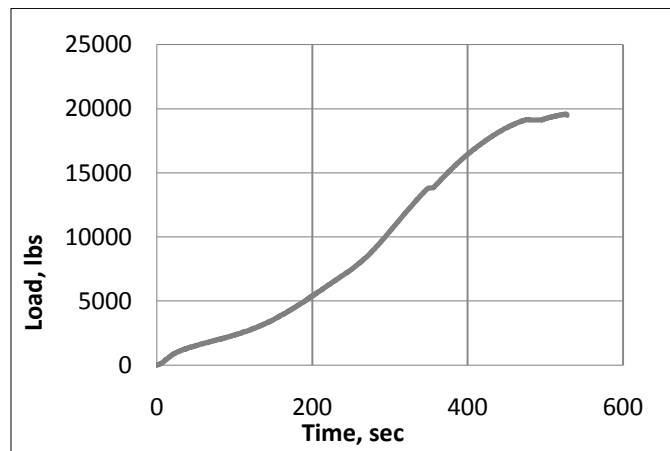
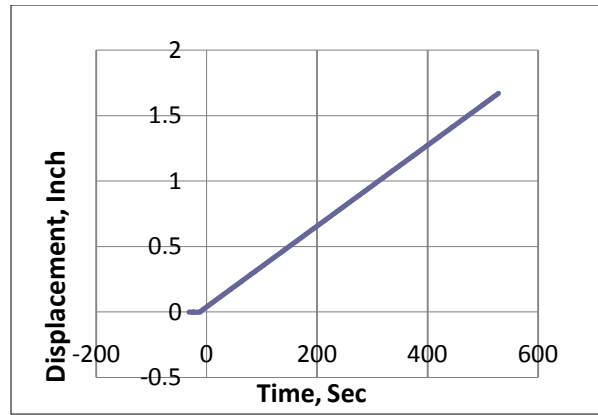
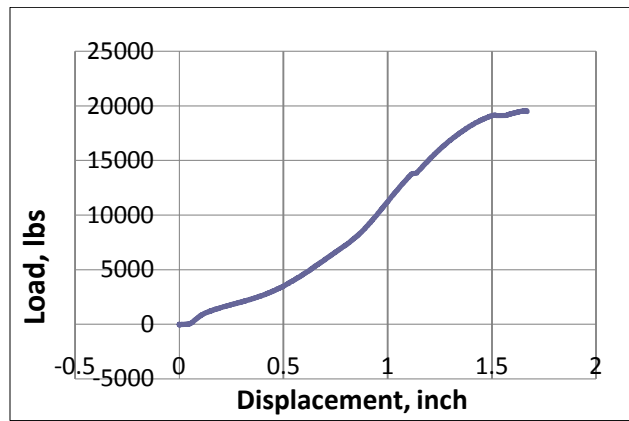
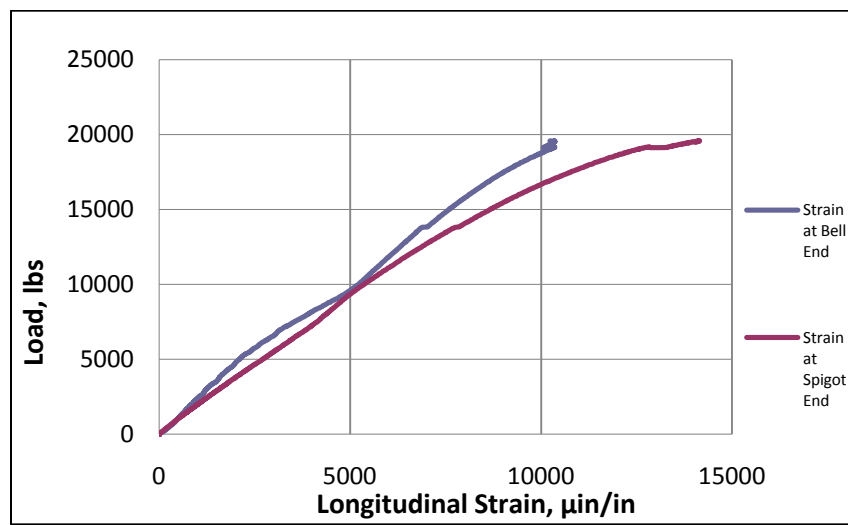
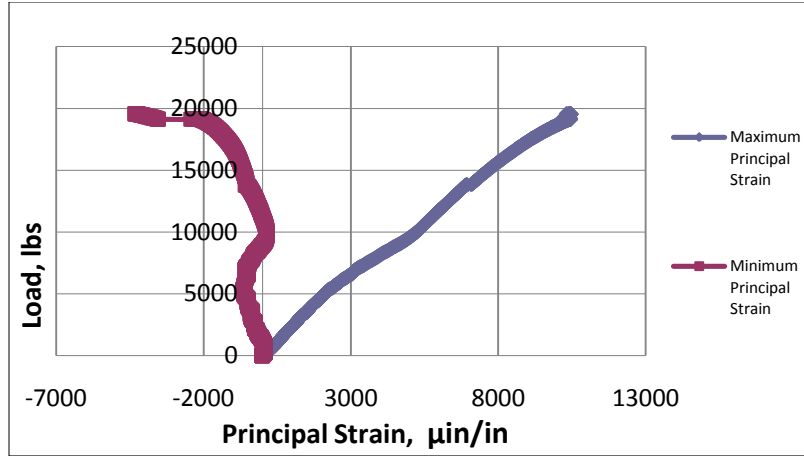
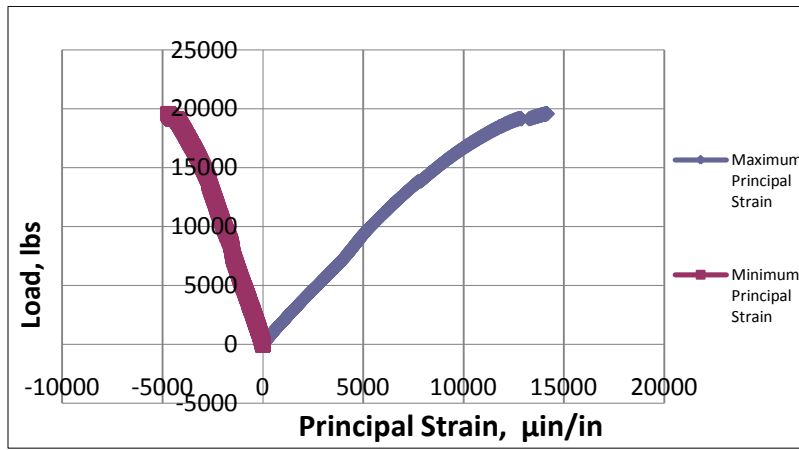
The load at the time of failure was 19,479 lbs (see Figure 6 for load curve) while the displacement was 1.67 inches (see Figure 7 for displacement curve). Figure 8 shows load-displacement curve for specimen one. Strain recorded on the center strain gages (longitudinal) of rectangular strain gage rosettes at the bell end and the spigot end at the time of failure read 10,259 $\mu\text{in/in}$ and 14,059 $\mu\text{in/in}$ respectively (see Figure 9 for longitudinal strain curve). Maximum and minimum principal strains recorded at bell end at the time of failure were 10,333 $\mu\text{in/in}$ and -4,103 $\mu\text{in/in}$ respectively at angle of 41 degrees clockwise of the first (R) strain gage. Maximum and minimum principal strains recorded at spigot end at the time of failure were 14,065 $\mu\text{in/in}$ and -4,690 $\mu\text{in/in}$ respectively at angle of 44 degrees clockwise of the first (R) strain gage. This showed that the principal strains were in the circumferential direction of the pipe assembly. Figure 10 and Figure 11 shows principal stresses curves for Bell and Spigot ends respectively.

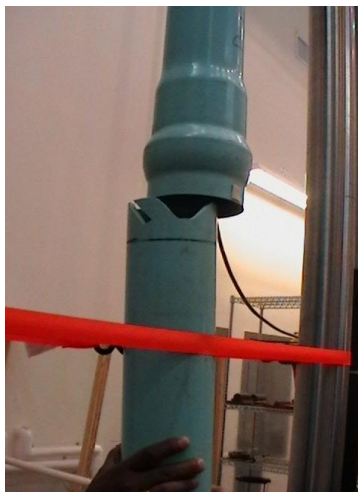
Figure 12: Failure of Specimen 2

Joint of the specimen 2 failed at the spigot of the pipe assembly as shown in Figure 12.

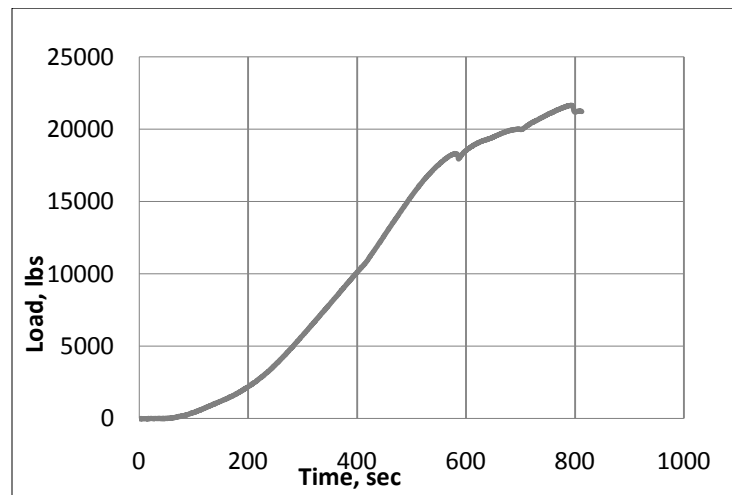
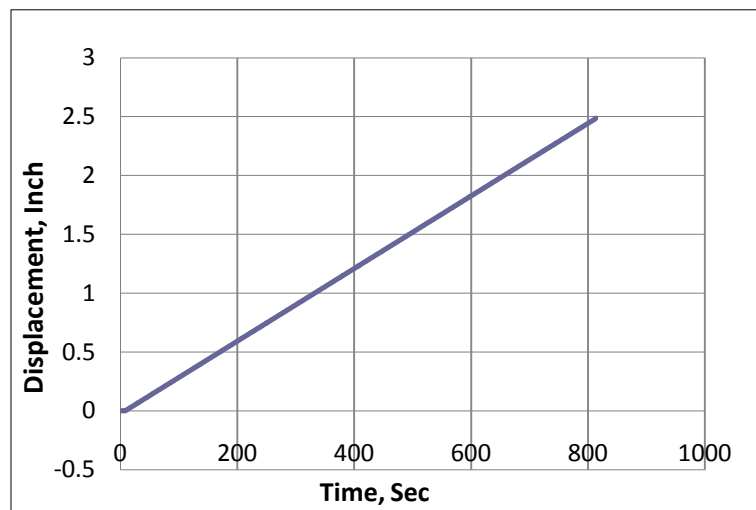
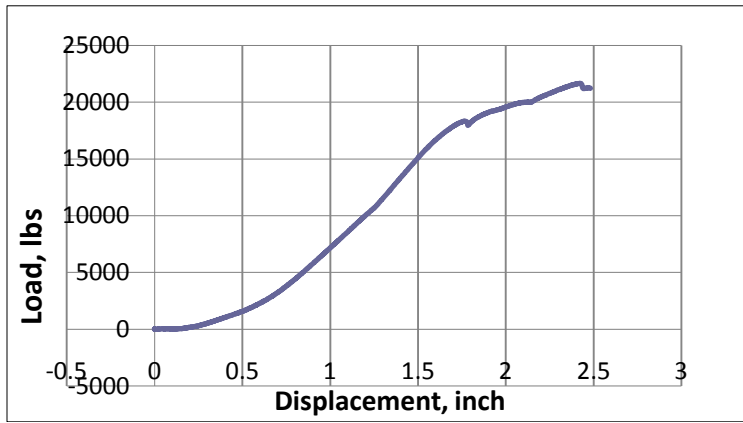
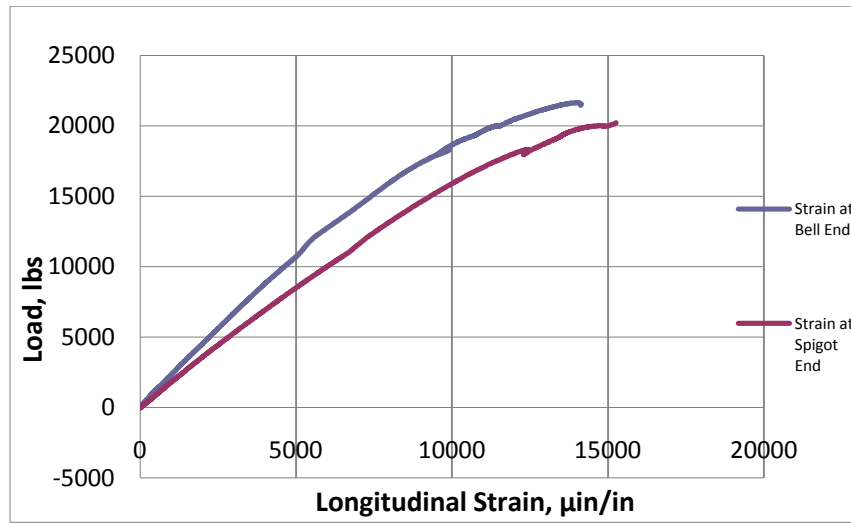
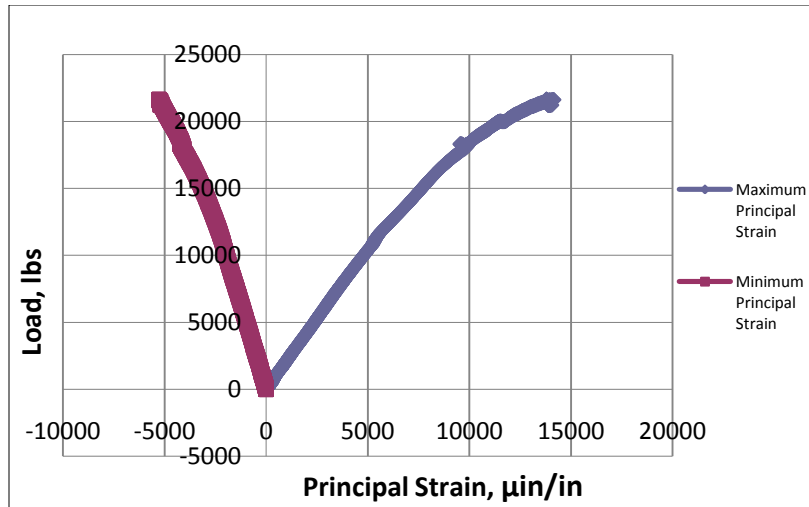
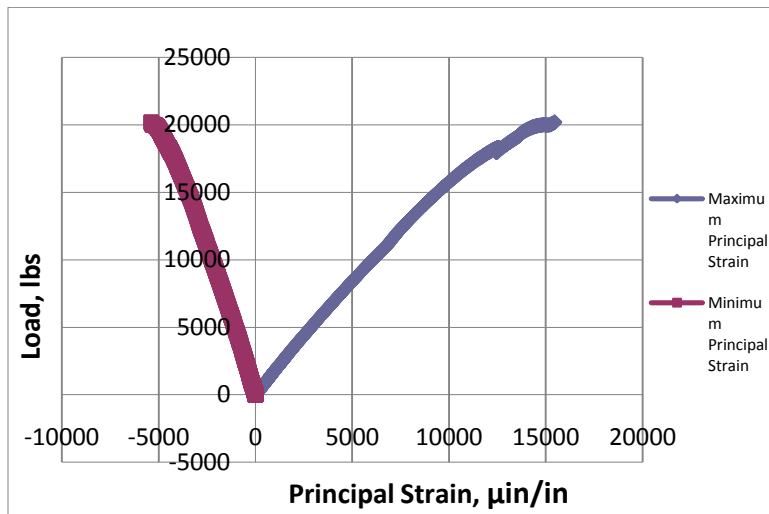
The load at the time of failure was 21,237 lbs (see Figure 13 for load curve) while the displacement was 2.48 inches (see Figure 14 for displacement curve). Figure 15 shows load-displacement curve for specimen 1. Strain recorded on the center strain gages (longitudinal) of rectangular strain gage rosettes at the bell end and the spigot end at the time of failure read 14,044 $\mu\text{in/in}$ and 3,001 $\mu\text{in/in}$ respectively (see Figure 16 for longitudinal strain curve). Maximum and minimum principal strains recorded at bell end at the time of failure were 14,029 $\mu\text{in/in}$ and -5,224 $\mu\text{in/in}$ respectively at angle of 44 degrees counter-clockwise of the first (R) strain gage. Maximum and minimum principal strains recorded at spigot end at the time of failure were 3,023 $\mu\text{in/in}$ and -1,560 $\mu\text{in/in}$ respectively at angle of 41 degrees counter-clockwise of the first (R) strain gage. This showed that the principal strains were in the longitudinal direction of the pipe assembly. Figure 17 and Figure 18 shows principal stresses curves for Bell and Spigot ends respectively.

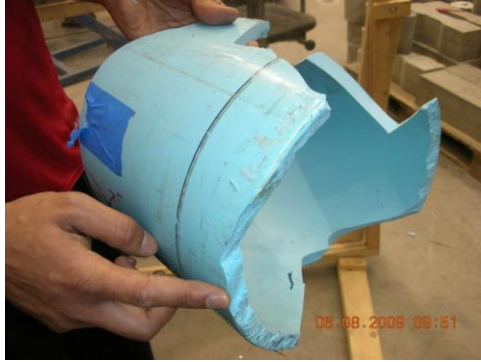
Figure 19: Pipe Piece after Failure of Specimen 3

Joint of the specimen 3 failed at the spigot of the pipe assembly. Crack initiated from the joint and resulted in failure at two locations of the pipe spigot end as shown in Figure 19.

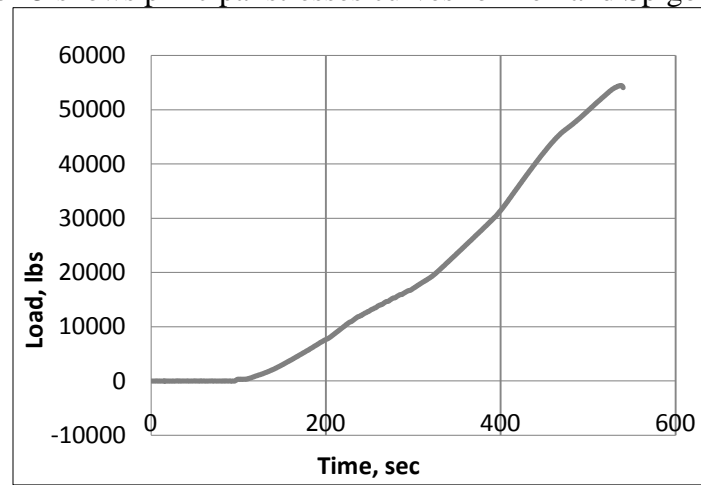
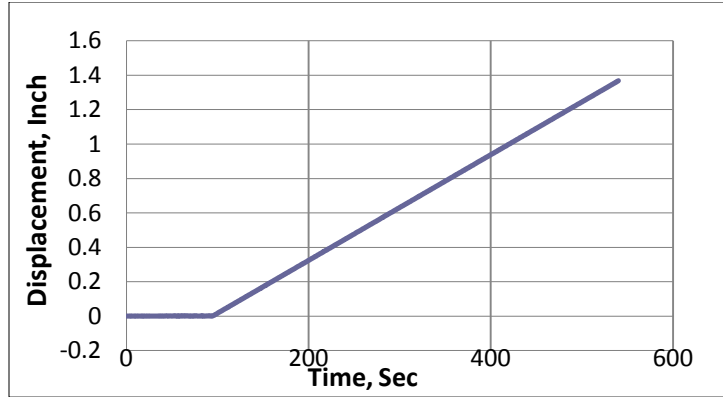
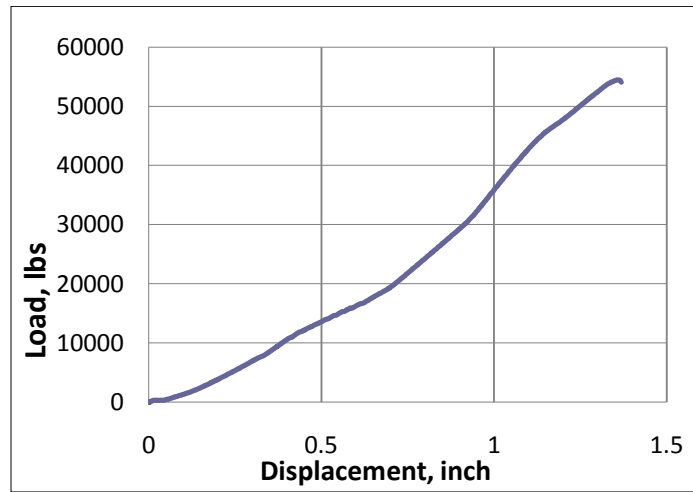
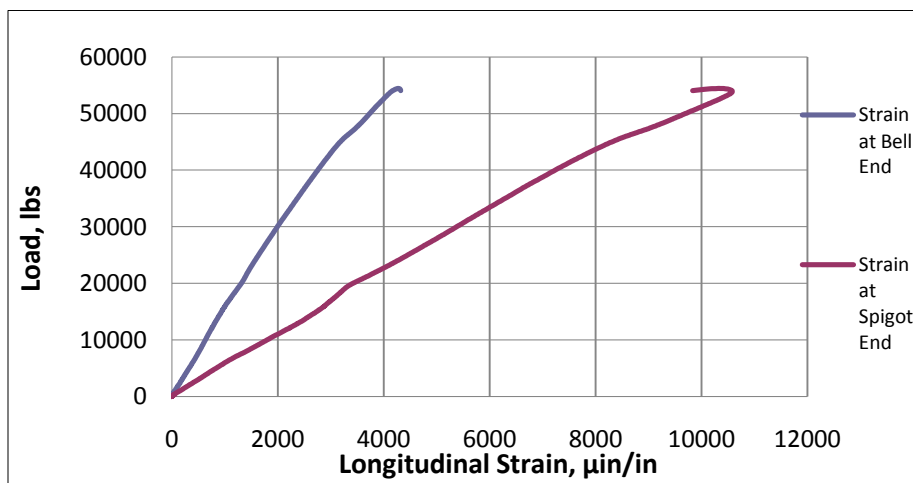
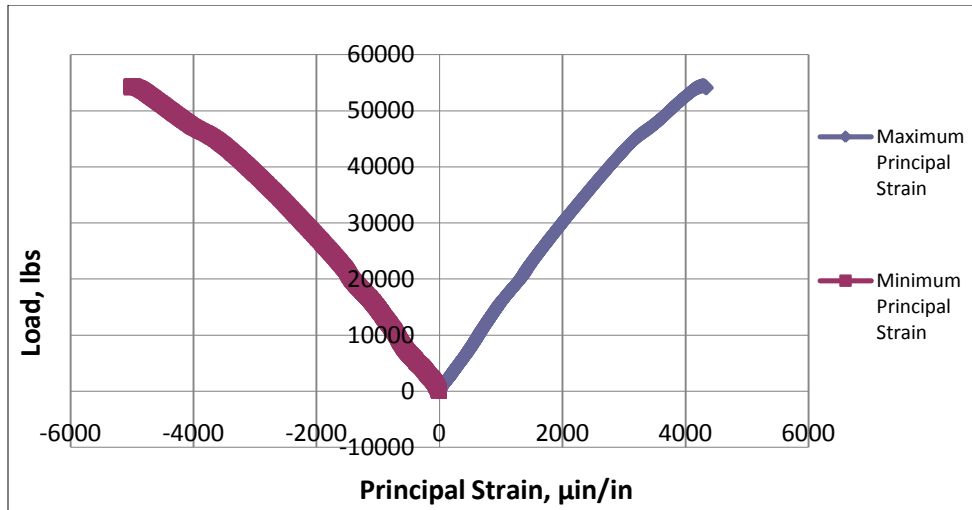
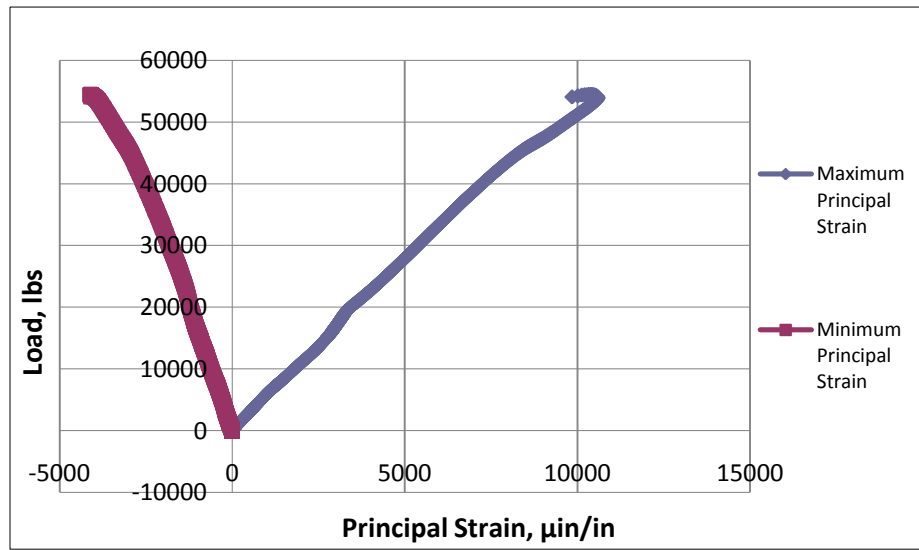
The load at the time of failure was 54,249 lbs (see Figure 20 for load curve) while the displacement was 1.37 inches (see Figure 21 for displacement curve). Figure 22 shows load-displacement curve for specimen 1. Strain recorded on the center strain gages (longitudinal) of rectangular strain gage rosettes at the bell end and the spigot end at the time of failure read 4,315 $\mu\text{in/in}$ and 10,001 $\mu\text{in/in}$ respectively (see Figure 23 for longitudinal strain curve). Maximum and minimum principal strains recorded at bell end at the time of failure were 4,336 $\mu\text{in/in}$ and -5,017 $\mu\text{in/in}$ respectively at angle of 43 degrees clockwise of the first (R) strain gage. Maximum and minimum principal strains recorded at spigot end at the time of failure were 10,012 $\mu\text{in/in}$ and -4,106 $\mu\text{in/in}$ respectively at angle of 43 degrees clockwise of the first (R) strain gage. This showed that the principal strains were in the circumferential direction of the pipe assembly. Figure 24 and Figure 25 shows principal stresses curves for Bell and Spigot ends respectively.

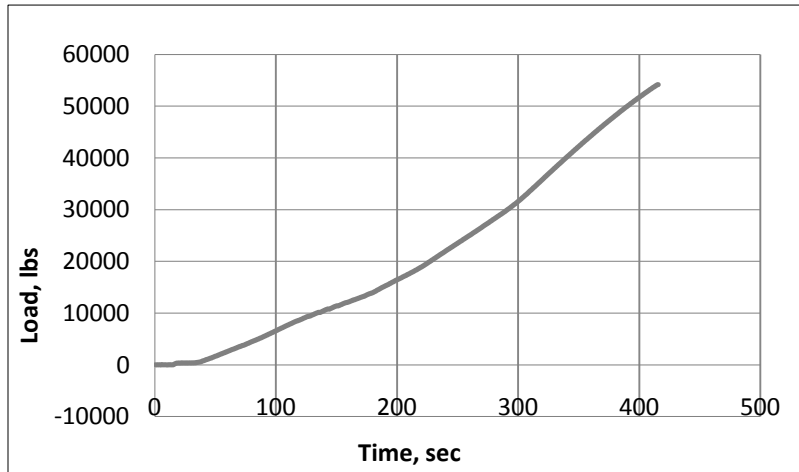
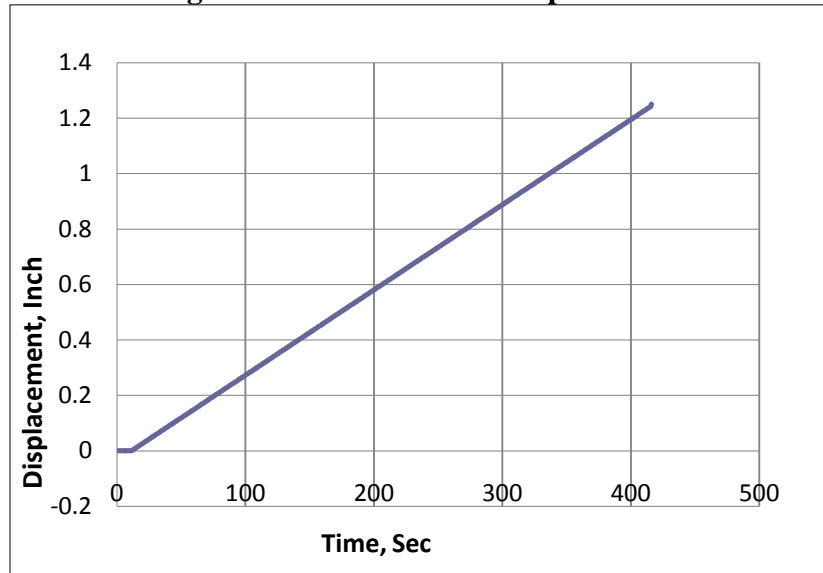
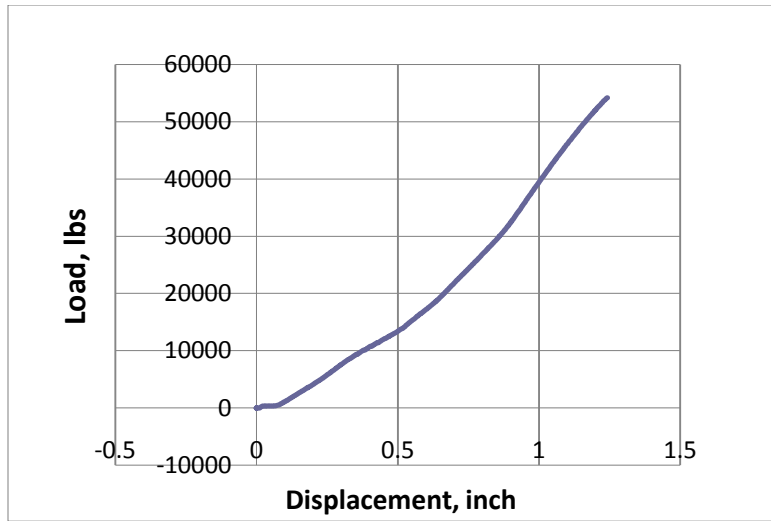
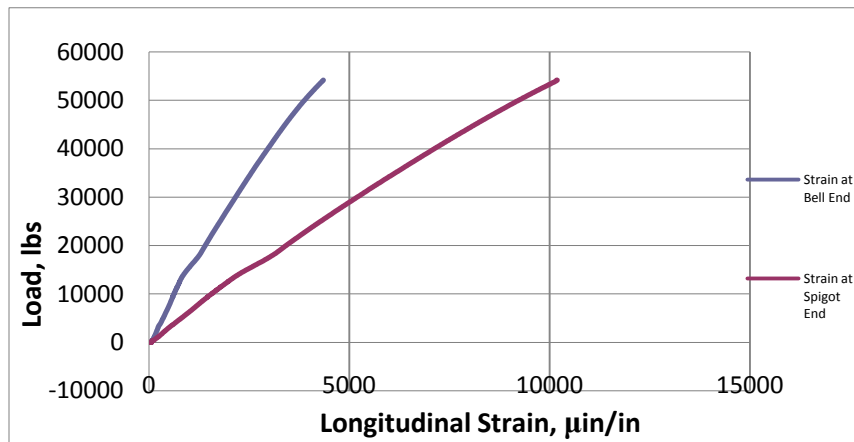
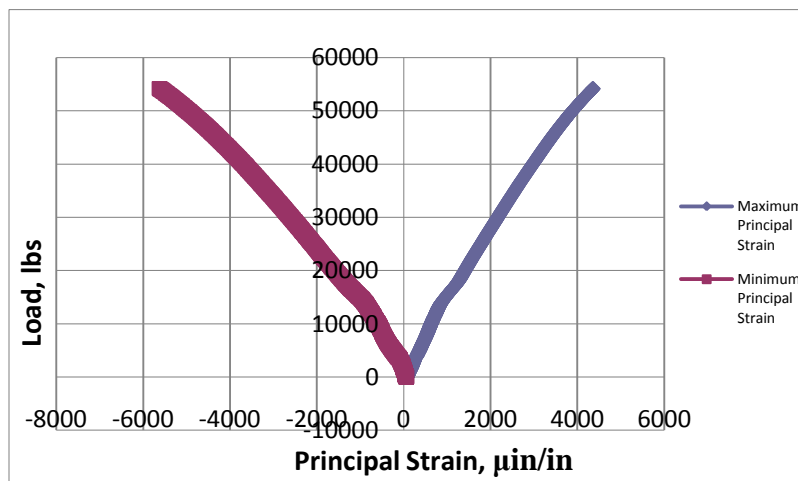
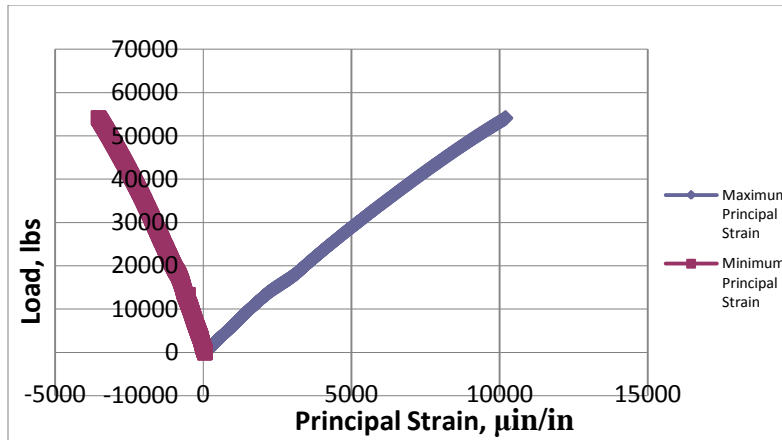
Joint of the specimen 4 failed at the spigot of the pipe assembly. The load at the time of failure was 54,181 lbs (see Figure 26 for load curve) while the displacement was 1.24 inches (see Figure 27 for displacement curve). Figure 28 shows load-displacement curve for specimen 1. Strain recorded on the center strain gages (longitudinal) of rectangular strain gage rosettes at the bell end and the spigot end at the time of failure read 4,355 $\mu\text{in/in}$ and 10,175 $\mu\text{in/in}$ respectively (see Figure 29 for longitudinal strain curve). Maximum and minimum principal strains recorded at bell end at the time of failure were 4,359 $\mu\text{in/in}$ and -5,631 $\mu\text{in/in}$ respectively at angle of 44 degrees clockwise of the first (R) strain gage. Maximum and minimum principal strains recorded at spigot end at the time of failure were 10,181 $\mu\text{in/in}$ and -3,549 $\mu\text{in/in}$ respectively at angle of 43 degrees counter-clockwise of the first (R) strain gage. This showed that the principal strains were in the circumferential direction at the bell end of the pipe while longitudinal at the spigot

end of the pipe assembly. Figure 30 and Figure 31 show principal stresses curves for Bell and Spigot ends respectively.

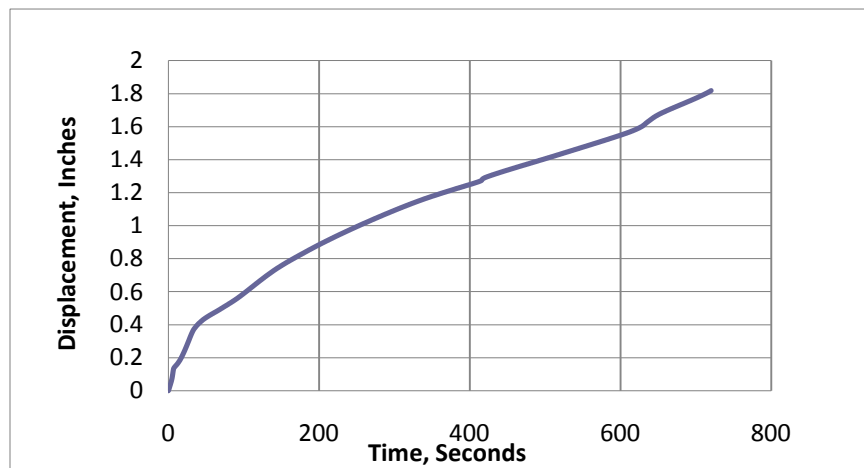
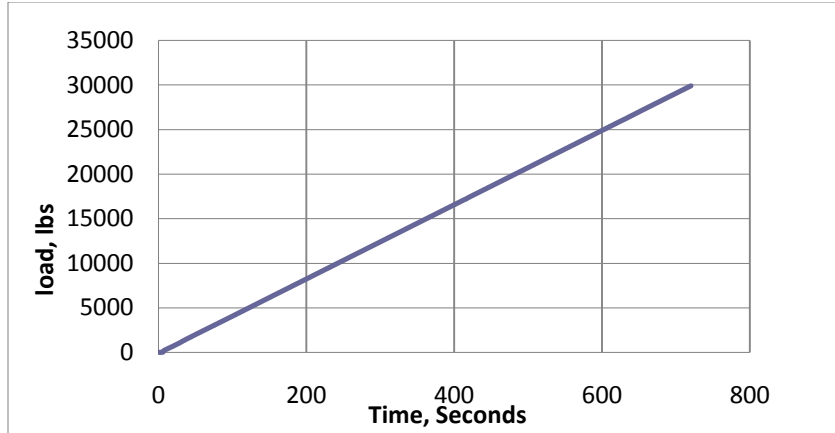
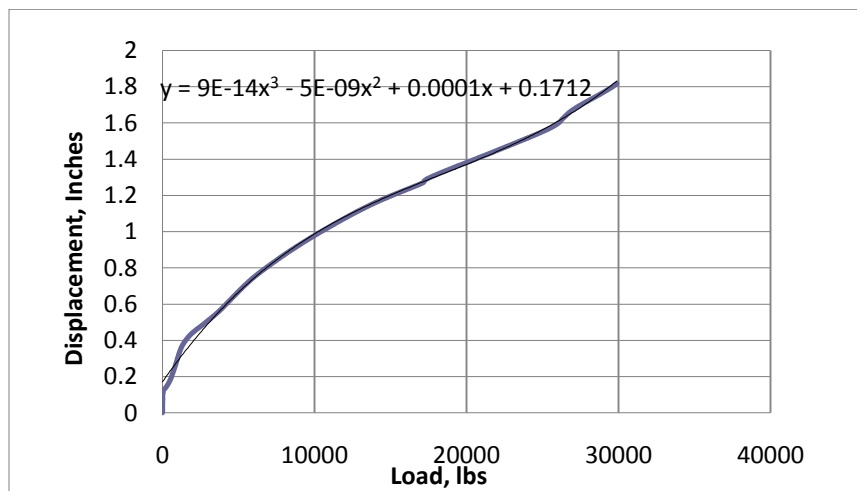
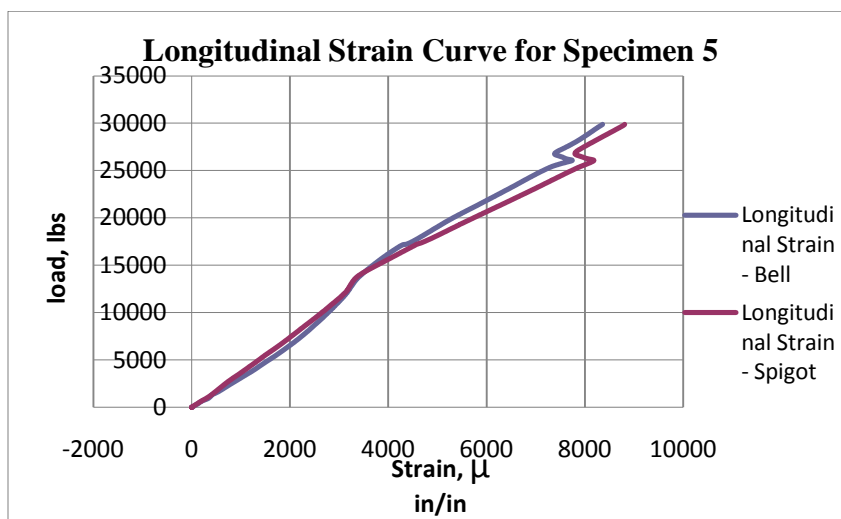
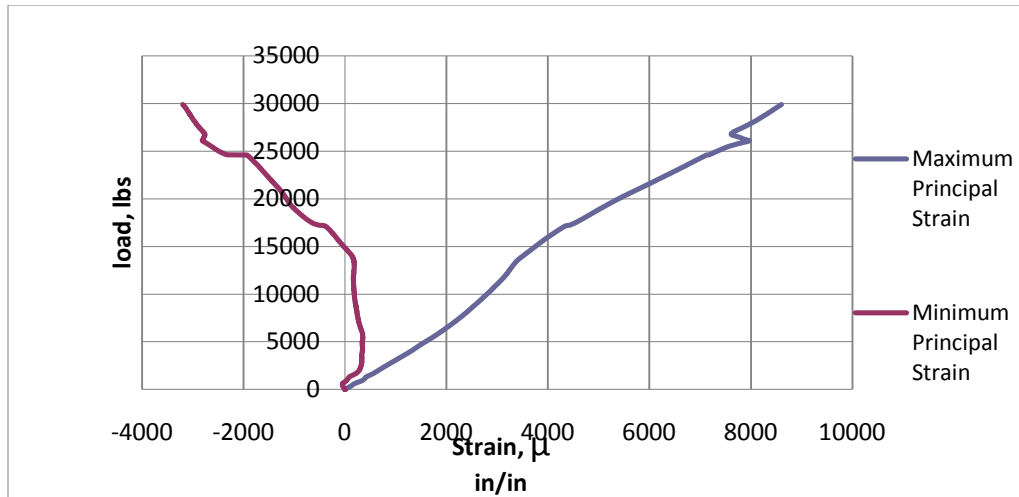
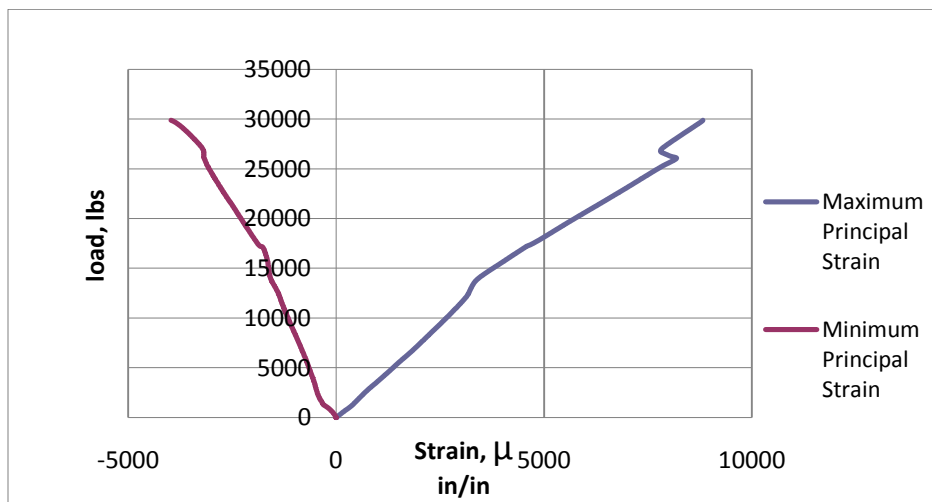
Joint of the specimen 5 failed at the spigot of the pipe assembly. The load at the time of failure was 29,895 lbs (see Figure 33 for load curve) while the displacement was 1.8177 inches (see Figure 32 for displacement curve). Figure 34 shows load-displacement curve for specimen 1. Strain recorded on the center strain gages (longitudinal) of rectangular strain gage rosettes at the bell end and the spigot end at the time of failure read 8,358 $\mu\text{in/in}$ and 8,809 $\mu\text{in/in}$ respectively (see Figure 35 for longitudinal strain curve). Maximum and minimum principal strains recorded at bell end at the time of failure were 8,605 $\mu\text{in/in}$ and -3,200 $\mu\text{in/in}$ respectively at angle of 37 degrees clockwise of the Right strain gage. Maximum and minimum principal strains recorded at spigot end at the time of failure were 8,823 $\mu\text{in/in}$ and -3,972 $\mu\text{in/in}$ respectively at angle of 43 degrees clockwise of the first Right strain gage. This showed that the principal strains were in the circumferential direction at both the bell and spigot ends of the pipe assembly. Figure 36 and Figure 37 show principal stresses curves for Bell and Spigot ends respectively.

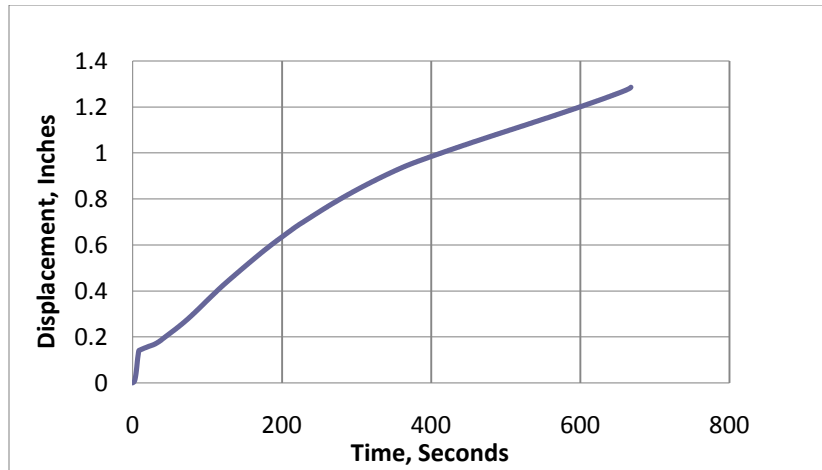
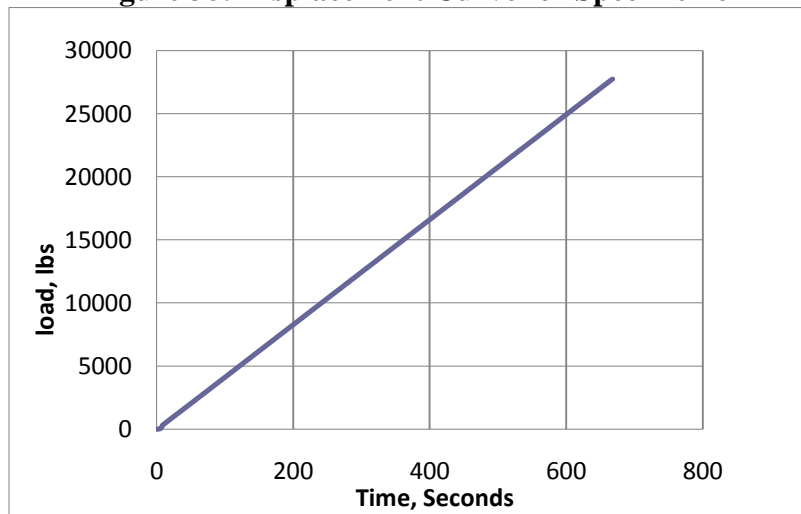
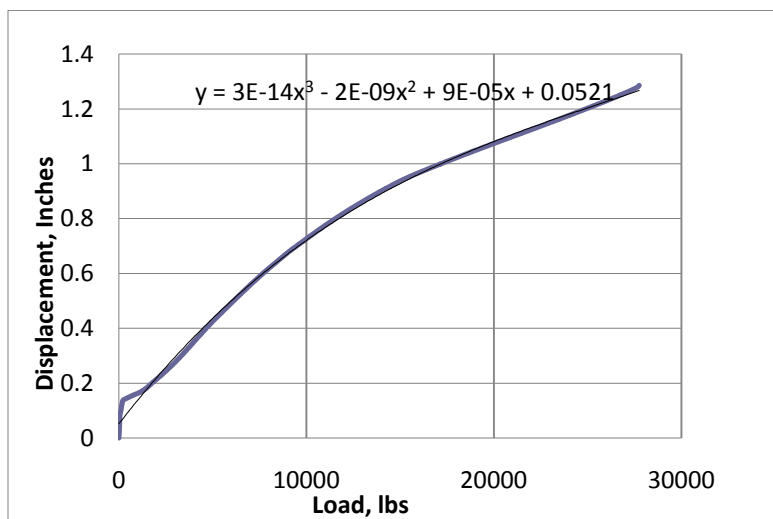
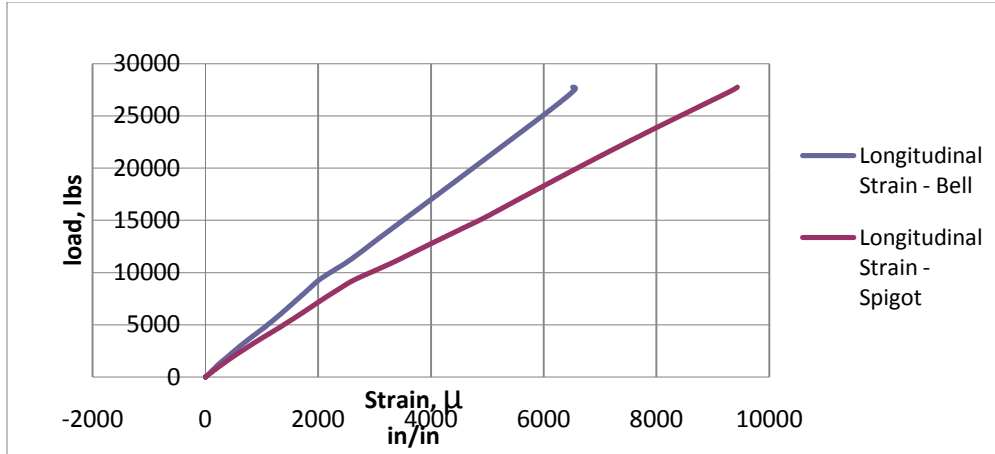
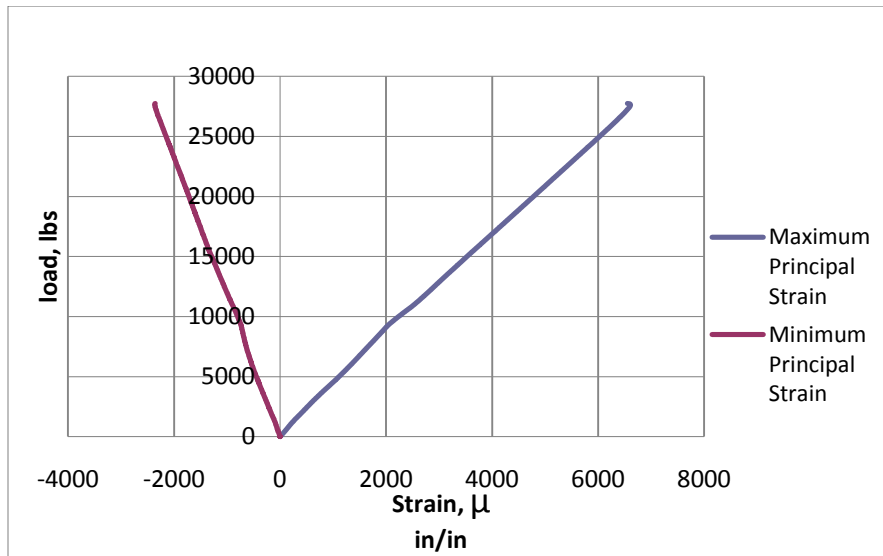
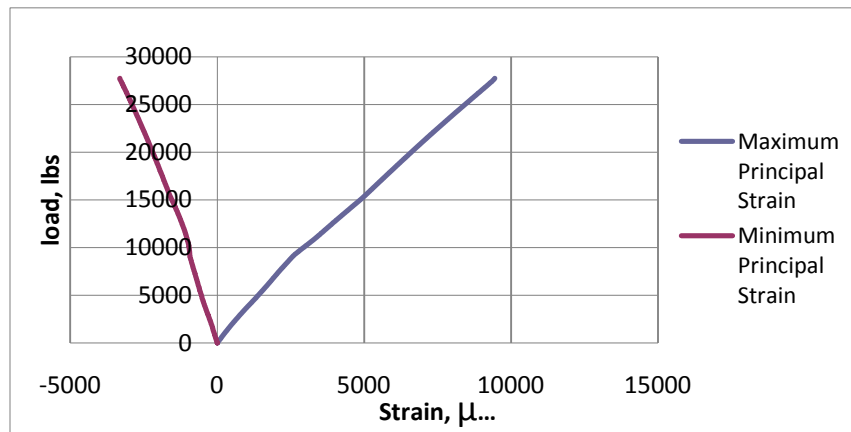
Joint of the specimen 6 failed at the spigot of the pipe assembly. The load at the time of failure was 27,747 lbs (see Figure 39 for load curve) while the displacement was 1.2856 inches (see Figure 38 for displacement curve). Figure 40 shows load-displacement curve for specimen 1. Strain recorded on the center strain gages (longitudinal) of rectangular strain gage rosettes at the bell end and the spigot end at the time of failure read 6,512 $\mu\text{in/in}$ and 9,435 $\mu\text{in/in}$ respectively (see Figure 41 for longitudinal strain curve). Maximum and minimum principal strains recorded at bell end at the time of failure were 6,554 $\mu\text{in/in}$ and -2,356 $\mu\text{in/in}$ respectively at angle of 41 degrees clockwise of the Right strain gage. Maximum and minimum principal strains recorded at spigot end at the time of failure were 9,447 $\mu\text{in/in}$ and -3,317 $\mu\text{in/in}$ respectively at angle of 43 degrees clockwise of the Right strain gage. This showed that the principal strains were in the circumferential direction at both the bell and spigot ends of the pipe assembly. Figure 42 and Figure 43 show principal stresses curves for Bell and Spigot ends respectively.
